### PROJECT SCOPE

Project:	Vanadium Project, Western Australia
Material:	Magnetite
Equipment:	Screw Feeder
Capacity:	150 TPH
Scope:	Upgrade of existing Kiln Feed Screw
Aim:	To increase wear life and reliability and reduce downtime for maintenance

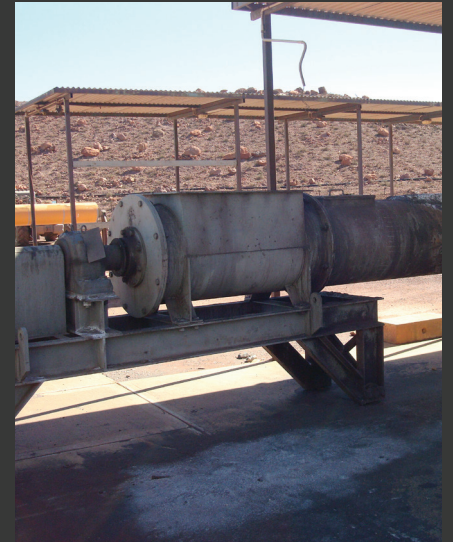
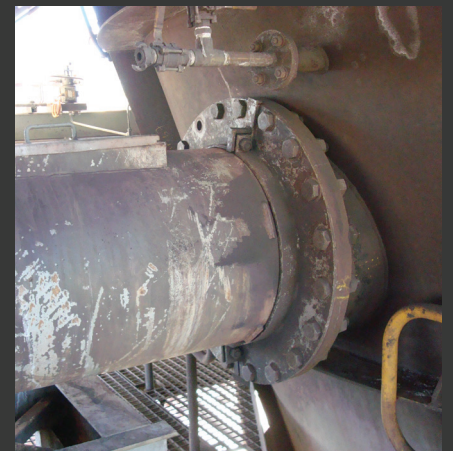
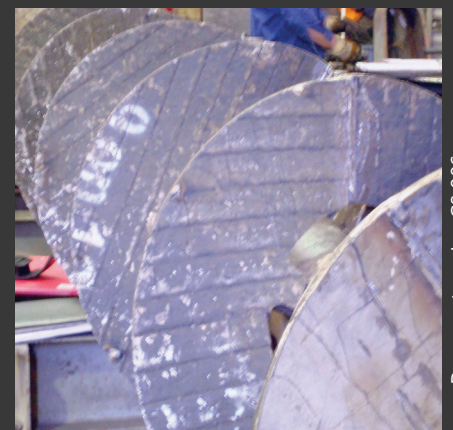
Flights:	Ribbon Style, weld overlay plate
End Bearing:	Dry Running journal bearing from complex carbide alloy steel
Drive:	Re-design of drive arrangement to increase filling efficiency and reduce rotation speed

To ensure the unit was back on site as soon as possible, the new components had been pre-made and the entire refurbishment was completed and workshop tested within 7 days for delivery back to site.
